Geotechnical comparative analysis of quarry A and quarry D at PT Indocement Prakarsa Tbk, Palimanan–Cirebon Unit

Rifki Adhy Santika¹

¹ Jenderal Achmad Yani University

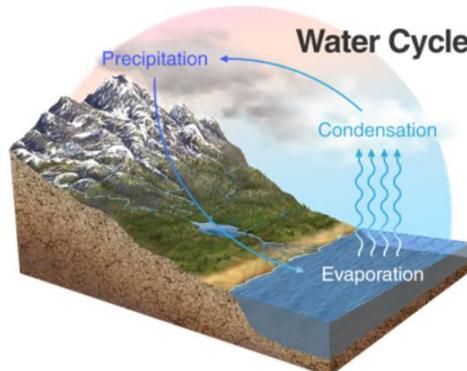
Figure 2. Hydrological Cycle

The diagram above illustrates the interrelationships and mutual influences among the lithosphere (the Earth's outermost solid layer), atmosphere, and hydrosphere, which together create the biosphere — the region of the Earth where all three systems interact and support life. This interaction results in the Earth's dynamic nature. The biosphere encompasses all forms of life, extending from the ocean floor upward through several kilometers of the atmosphere, forming a continuous and interconnected zone of life on Earth.

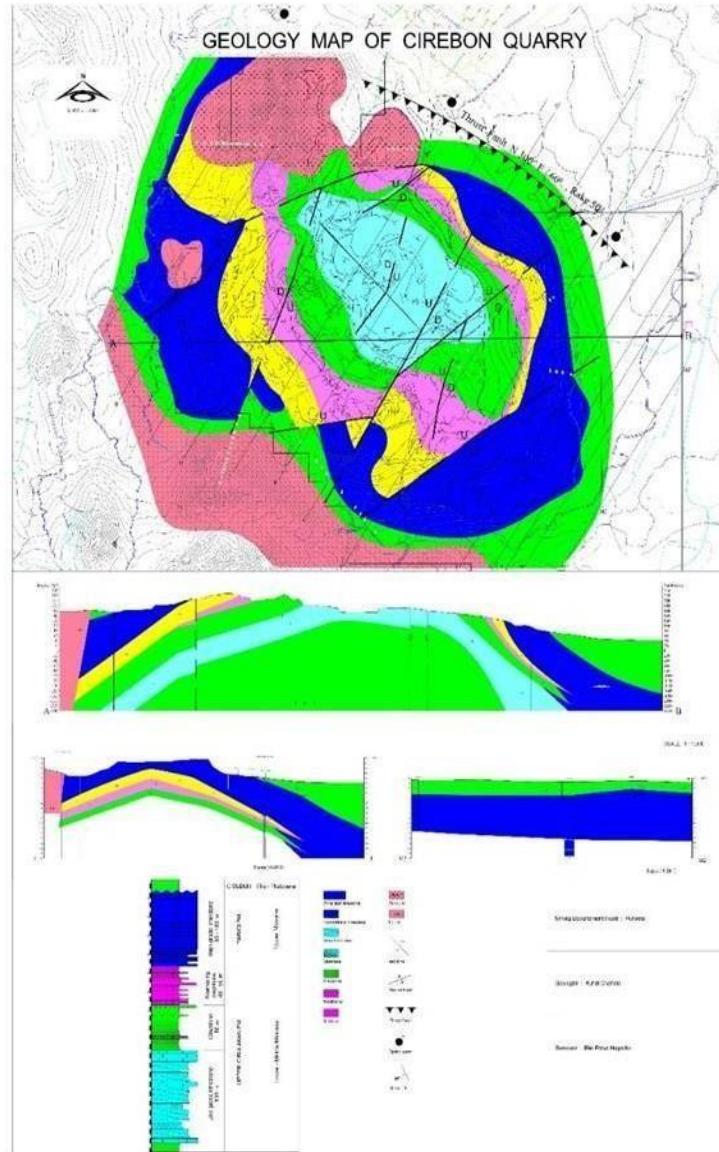
Figure 3. Geological Map of the Quarry
Source: Mining Department

The geological map of the quarry area illustrates the distribution and types of rock formations present at the mining site. Based on the map, the study area consists of several rock units such as limestone, claystone, sandstone, and breccia, which are distributed both laterally and vertically. The dominant geological formation is the Kromong Complex Limestone, a high-quality carbonate rock characterized by a high CaO content.

In addition, the presence of volcanic formations and andesitic intrusions indicates past tectonic and volcanic activity in the region. The map also shows geological structural patterns such as folds and joints, which are critical factors in slope stability analysis and mine design.

The existence of folded hill morphology and the orientation of discontinuity planes serve as key indicators for assessing landslide potential and for planning safe mining operations.
